# NATIONAL TRANSPORTATION SAFETY BOARD

## SPECIAL INVESTIGATION REPORT

WING FAILURE OF BOEING 747-131  
NEAR MADRID, SPAIN  
MAY 9, 1976

AAR-78-12  
c. 3

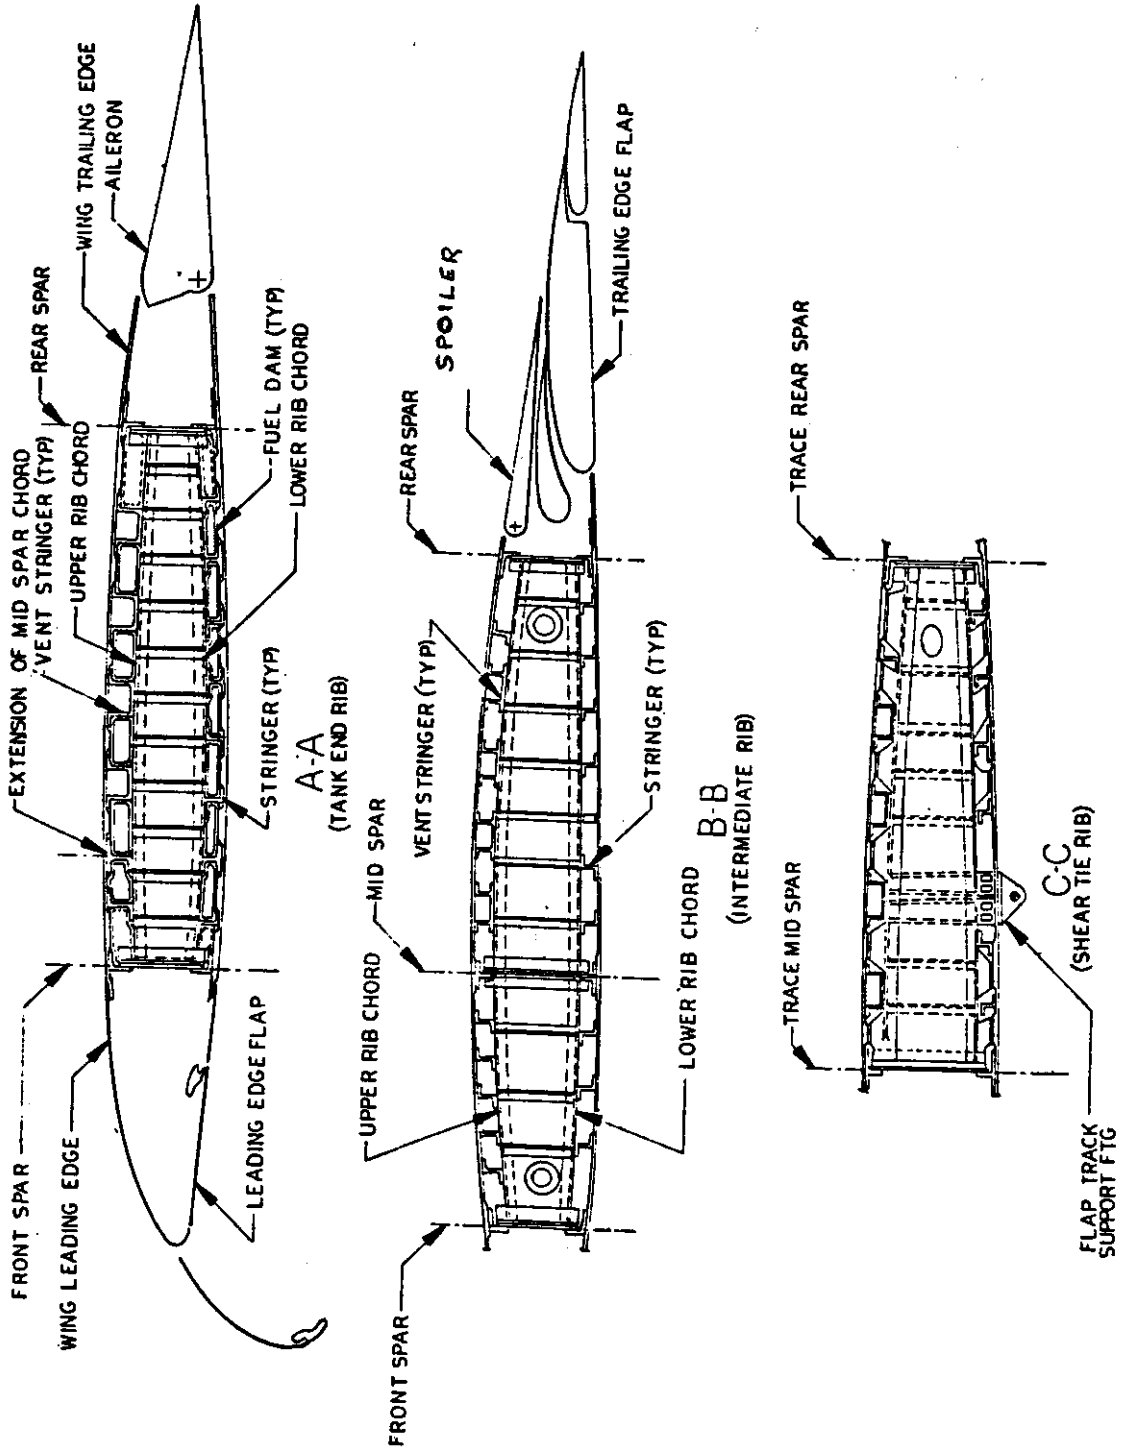
Pitting and localized burn areas typical of lightning attachment damage were found on the left wingtip and on the vertical fin at the VOR antenna. The left wing had separated into 15 major pieces before ground impact and parts of it were found at each location of wreckage. (See drawing on page 31.)

— SEPARATION LINES

WING STATIONS
